Total Fluid and Vapour Recovery Across a Commercial Fuel Station Following a Petroleum Release

Abstract

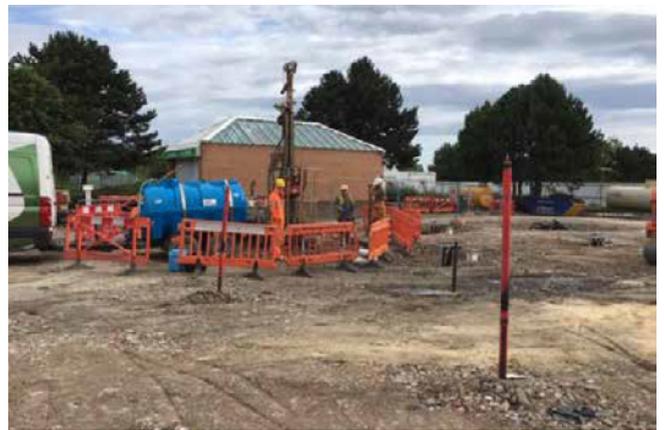
The sub-surface conditions of the site comprise **extremely heterogenous mixtures of coal ash, slabs** of mudstone and fractured sandstone blocks bound by an **unstable clay matrix** to depths of 20+ metres below ground level. This has created an **unpredictable** and **uneven groundwater surface across site** with areas of near surface groundwater mounding in places and dry stratigraphy in others. The coal bearing, mined bedrock on site is estimated to be up to 15m below ground level.

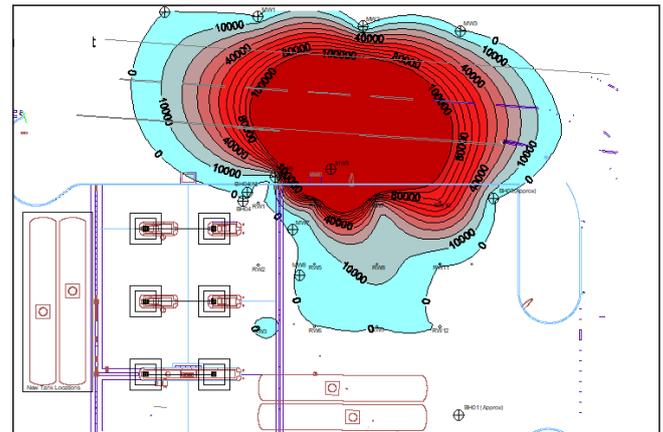
Pre-remediation Hydrocarbon Concentrations.

Early trial pit investigations and detailed rotary drilling investigations identified a **dissolved phase plume around 100m³ in area migrating south-east** from the site towards a residential area. The core of this plume centred around a set of fuel distribution islands on the historic forecourt with a free petroleum product (degraded diesel) around the leak point.

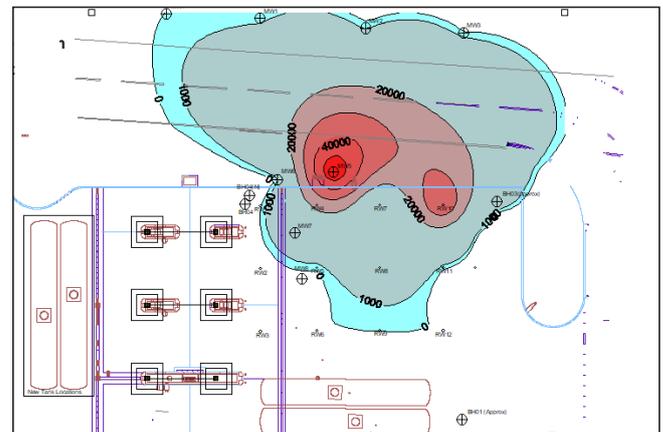
Mid Works Monitoring Visit Hydrocarbon Concentrations.

The groundwater remediation system has pumped ~1500 m³ of contaminated groundwater to date, stopping the migration of the plume of both soil vapour and fuel oil off-site. Groundwater concentrations of total petroleum hydrocarbon (Σ TPH) have been **reduced from in excess of c.300,000 mg/L to 1050 mg/L**. Volatile Organic Compound measurements on site have been vastly **reduced from 3000ppm to <80ppm** in the sub-surface. This has enabled the continued operation of the site and the protection of nearby homes.

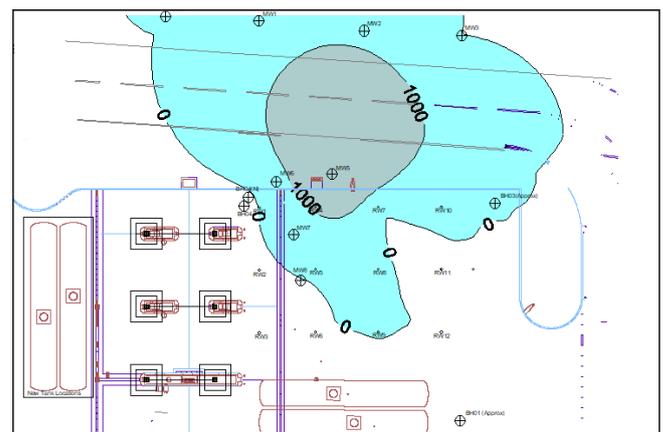
Late Stage Monitoring Visit Hydrocarbon Concentrations.
